# HANDLING INSTRUCTIONS for 15 cm base unit pull-out

15 cm base unit pull-out, 2-tier

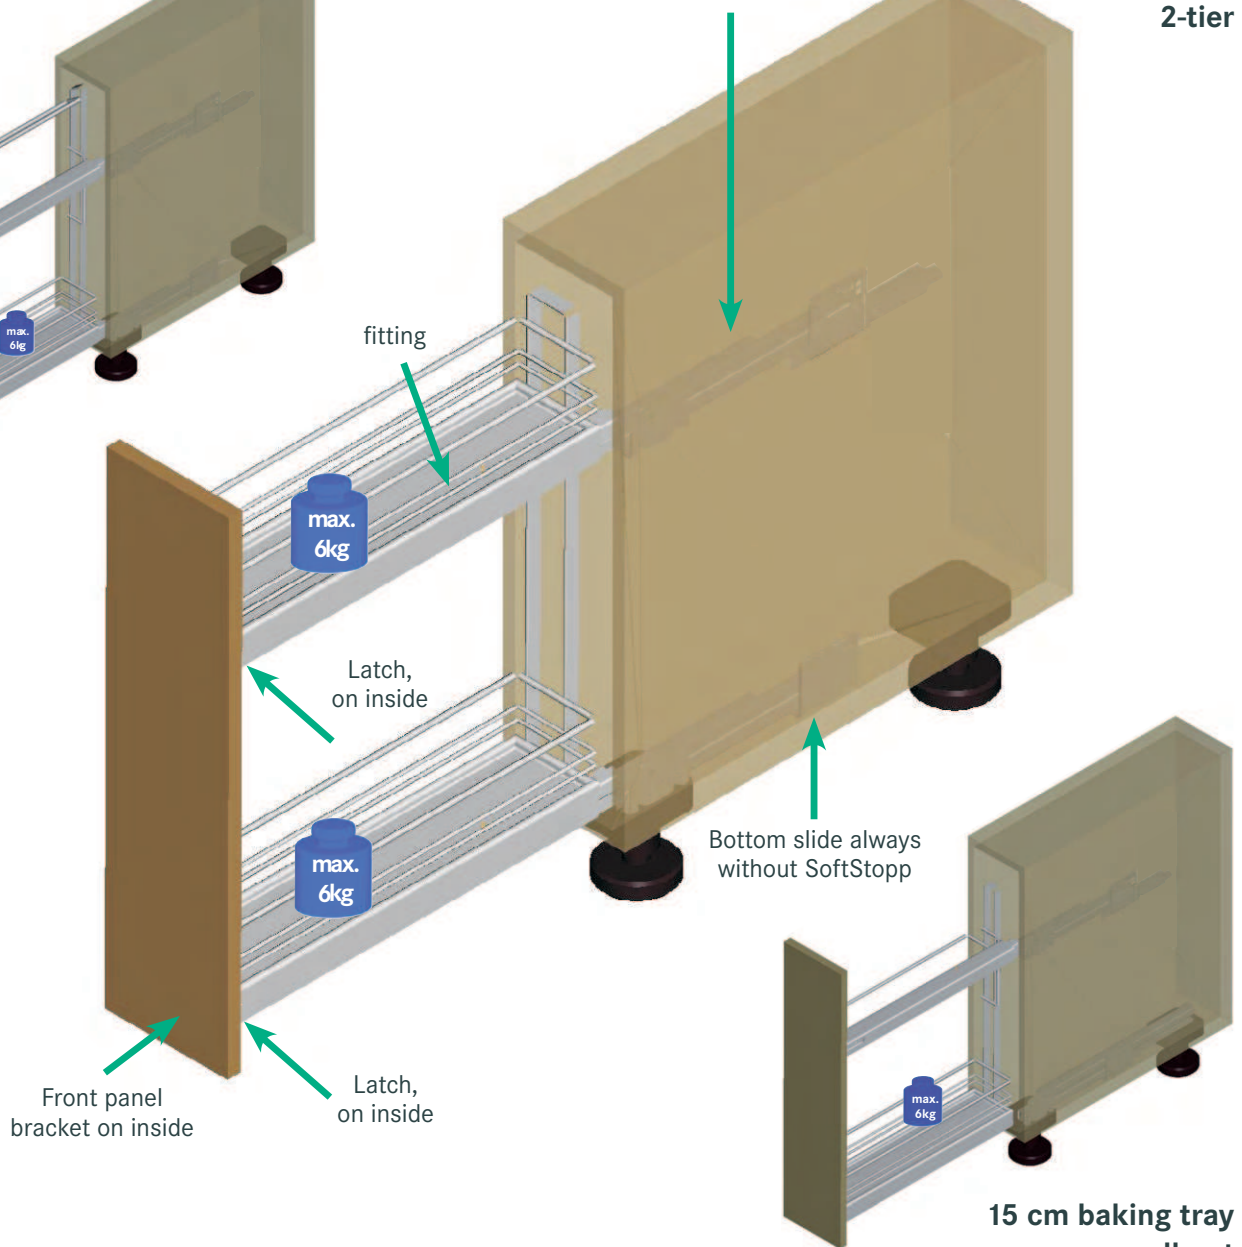
Top slide optionally with SoftStopp

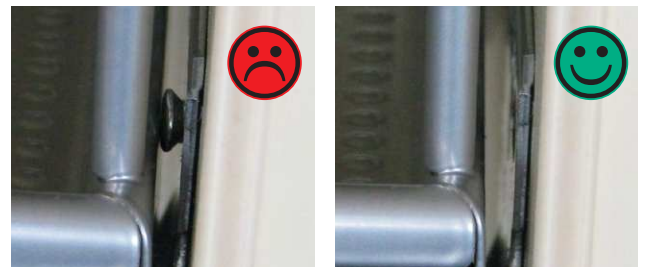
### 3.1 Incorrect screws (pan head/oval head)?

**Caution:** Do not overtighten the screws. Do not use screws that rub against the fitting after assembly. The screws must be turned in straight and tightened firmly.

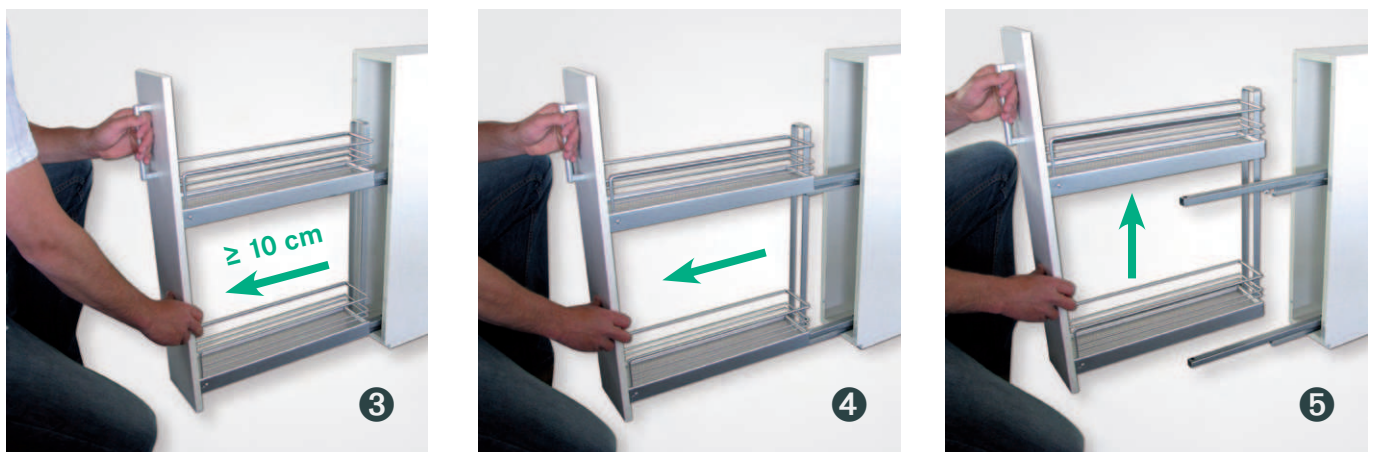
Pull out front panel with fitting until clear of unit (approx. 10 cm).  
Then lift off.
