HANDLING INSTRUCTIONS for 15 cm base unit pull-out

15 cm base unit pull-out, 2-tier

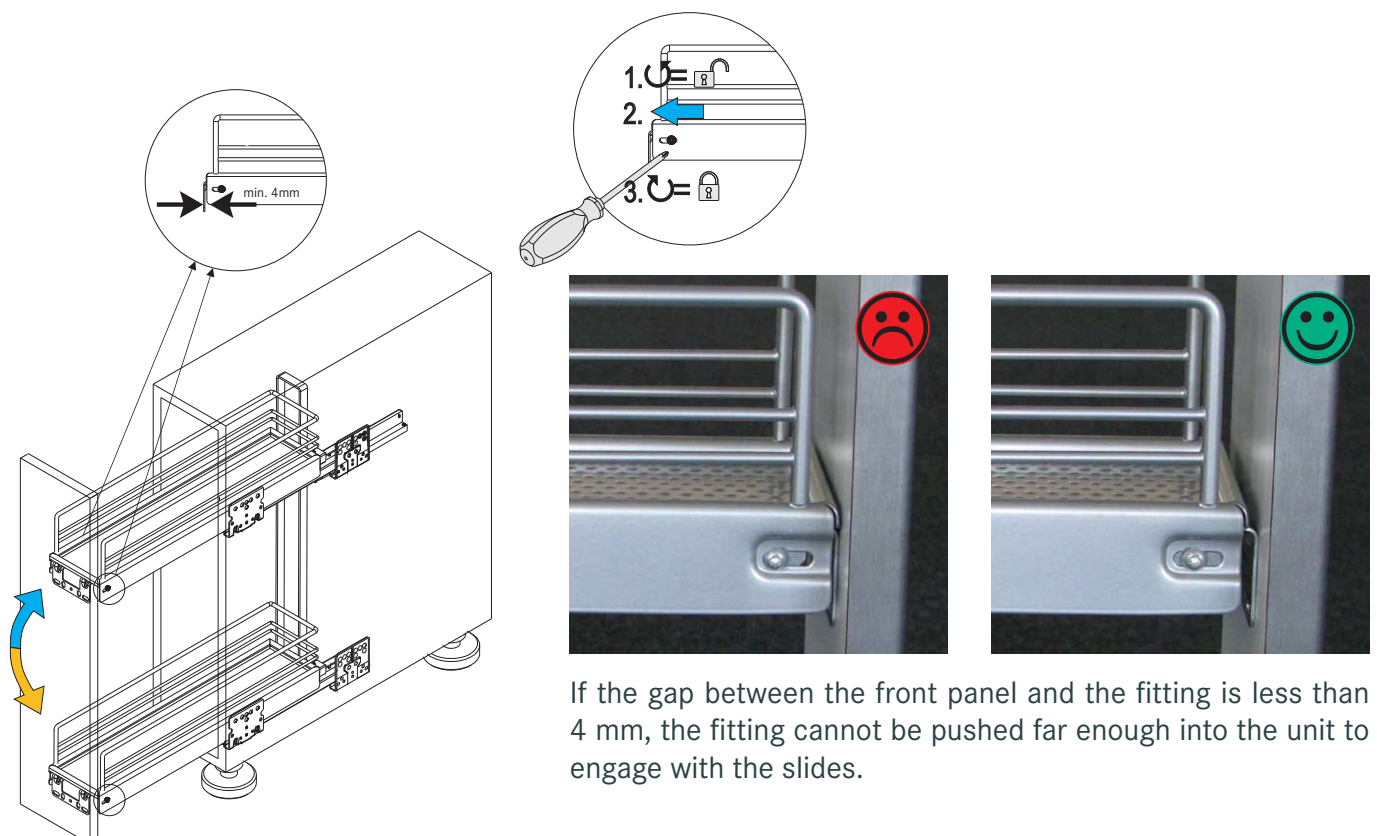
1.4 Front panel brackets as supplied (4-mm gap)

If the gap between the front panel and the fitting is less than 4 mm, the fitting cannot be pushed far enough into the unit to engage with the slides.

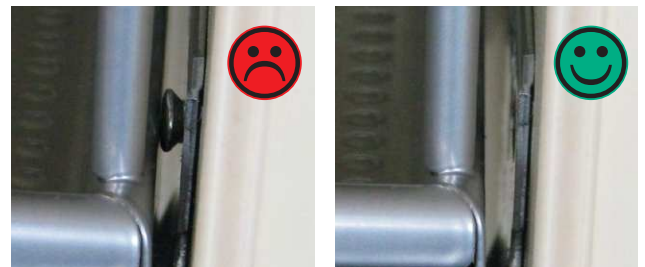
3.1 Incorrect screws (pan head/oval head)?

Caution: Do not overtighten the screws. Do not use screws that rub against the fitting after assembly. The screws must be turned in straight and tightened firmly.

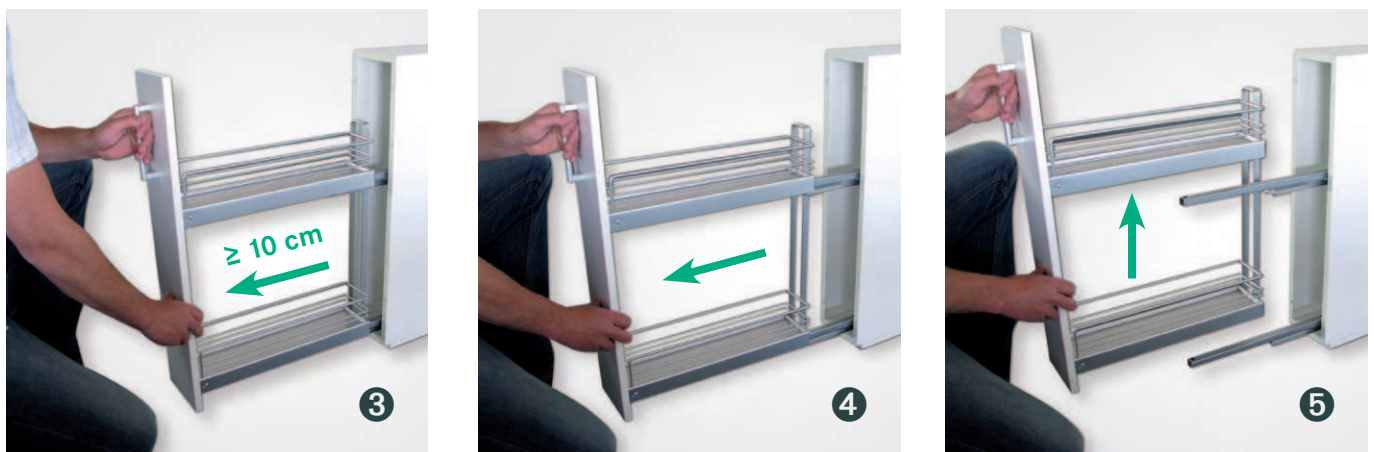
Pull out front panel with fitting until clear of unit (approx. 10 cm).
Then lift off.
