HANDLING INSTRUCTIONS for 15 cm base unit pull-out

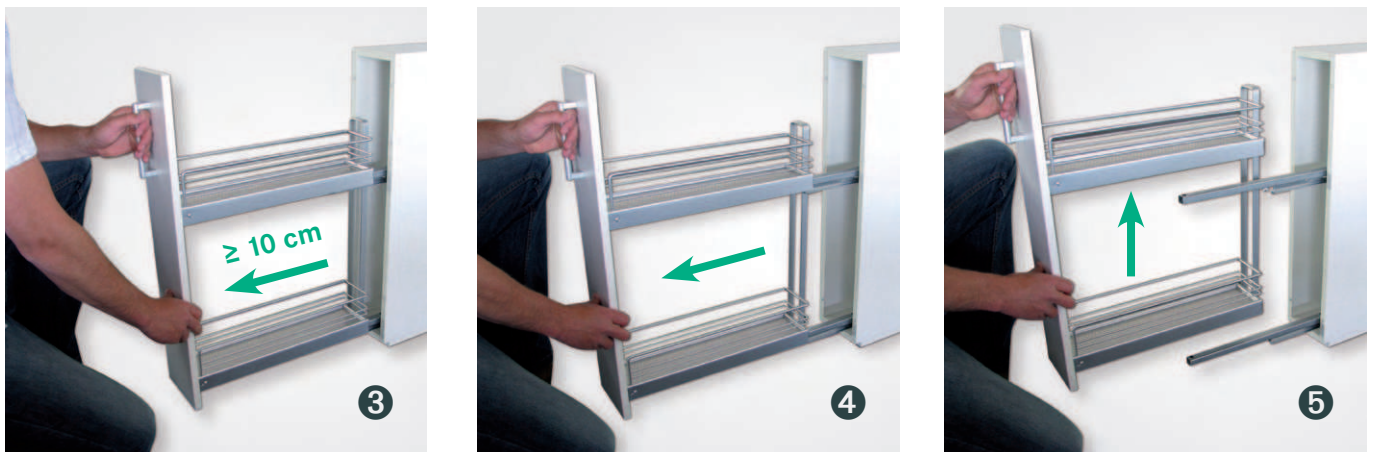
Pull out front panel with fitting until clear of unit (approx. 10 cm).
Then lift off.

Caution: After disassembly check that latches are back in 0-position.
See also 1.2 on page 2.
