HANDLING INSTRUCTIONS for 15 cm base unit pull-out

Problem	Possible failure	Possible solution (summary)	Detailed advice
1. Fitting does not engage with slides.	Is fitting positioned correctly on slides?	Place fitting correctly on slides.	1.1
	Latch not in 0-position?	Set latch to 0-position.	1.2
	Are slides positioned correctly?	Position bottom/top slide correctly.	1.3
	Front panel brackets as supplied (4-mm gap)?	Increase gap between front panel bracket and fitting.	1.4
2. Unit does not close.	Is the unit set up correctly?	Align unit.	2.1
	Are the two slides parallel?	Position bottom/top slides correctly.	2.2
3. The fitting rubs.	Are screws tightened firmly? Are you using the correct screws (pan head, oval head)?	1. Tighten screws. 2. Use correct screws.	3.1
	Is the unit set up correctly?	Align unit.	3.2
4. Disassembly			4.0

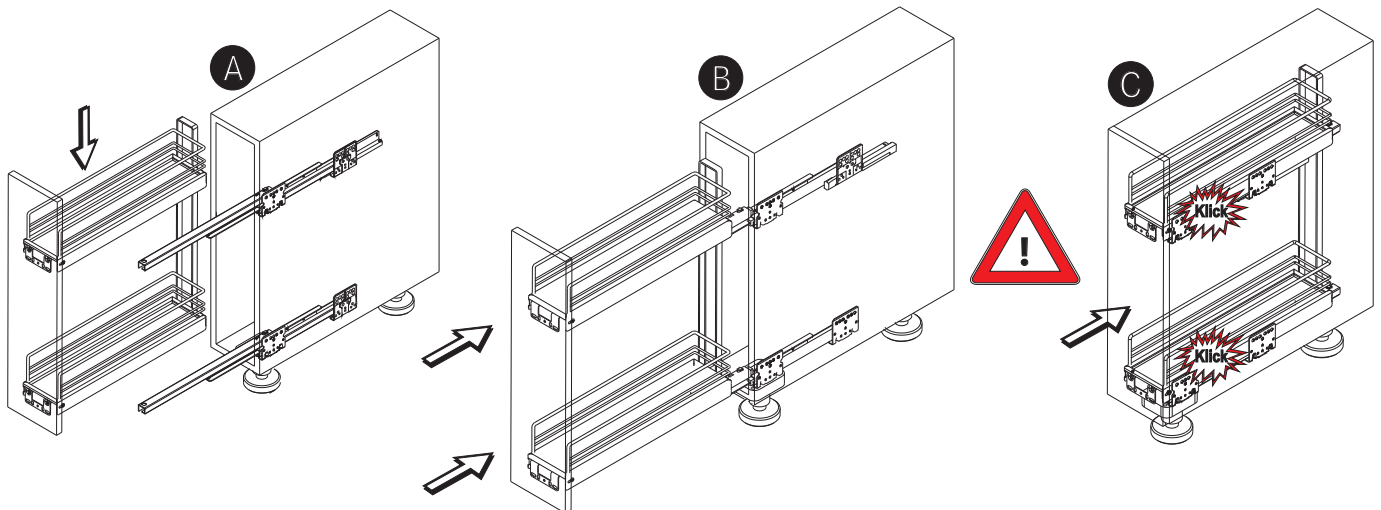
1.1 Is fitting positioned correctly on slides?

Pull slides fully out of the unit. Push fitting onto slides and then back into the unit. An audible click means that the slides have engaged with the fitting.

Caution: The fitting must be level when placed on the slides. Press on the front panel opposite the front panel brackets when pushing in the fitting.

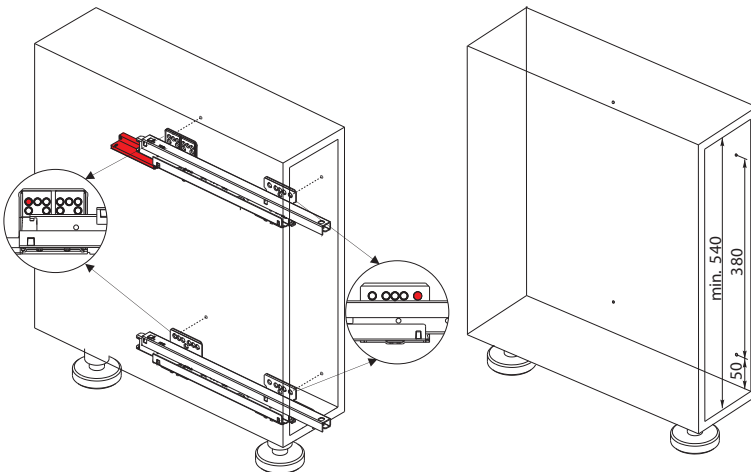
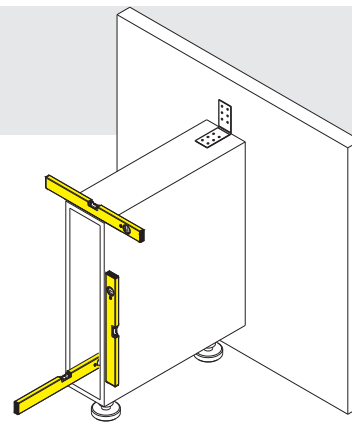
2.2 Are the slides parallel to each other?

The slides must be fitted parallel to each other. In addition, it is important that the dimension of 380 mm is maintained exactly.

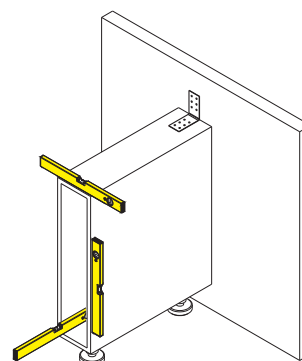
3.2 Is the unit set up correctly?

Ensure that the side panels are straight and vertical.

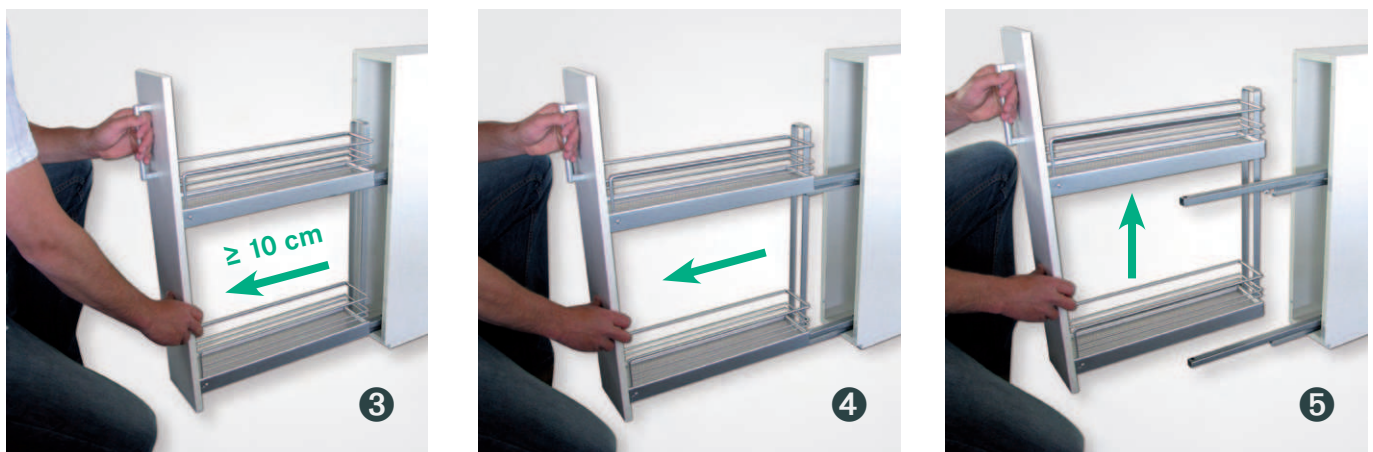
Pull out front panel with fitting until clear of unit (approx. 10 cm).
Then lift off.

Caution: After disassembly check that latches are back in 0-position.
See also 1.2 on page 2.
