HANDLING INSTRUCTIONS for 15 cm base unit pull-out

Problem	Possible failure	Possible solution (summary)	Detailed advice
1. Fitting does not engage with slides.	Is fitting positioned correctly on slides?	Place fitting correctly on slides.	1.1
	Latch not in 0-position?	Set latch to 0-position.	1.2
	Are slides positioned correctly?	Position bottom/top slide correctly.	1.3
	Front panel brackets as supplied (4-mm gap)?	Increase gap between front panel bracket and fitting.	1.4
2. Unit does not close.	Is the unit set up correctly?	Align unit.	2.1
	Are the two slides parallel?	Position bottom/top slides correctly.	2.2
3. The fitting rubs.	Are screws tightened firmly? Are you using the correct screws (pan head, oval head)?	1. Tighten screws. 2. Use correct screws.	3.1
	Is the unit set up correctly?	Align unit.	3.2
4. Disassembly			4.0

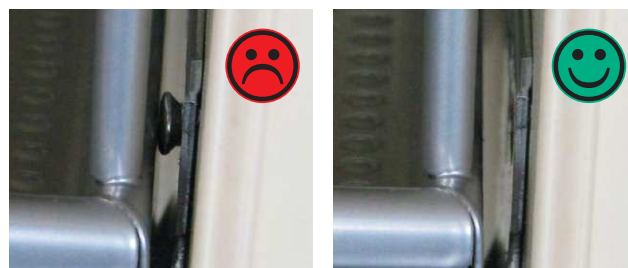
3.1 Incorrect screws (pan head/oval head)?

Caution: Do not overtighten the screws. Do not use screws that rub against the fitting after assembly. The screws must be turned in straight and tightened firmly.
